Protective Coating Puts Stop to Headworks Corrosion

The Fresno/Clovis Regional Wastewater Reclamation Facility provides wastewater treatment and disposal for 97 percent of the 520,000 population in the Fresno-Clovis Metropolitan Area, one of the fastest growing communities in California. The 1700 acre property located southwest of Fresno originated in 1891 as a 40-acre disposal area. In the years that followed, the wastewater system successfully evolved through a series of expansions to respond to the needs of a growing population and to comply with increasingly stringent discharge requirements.

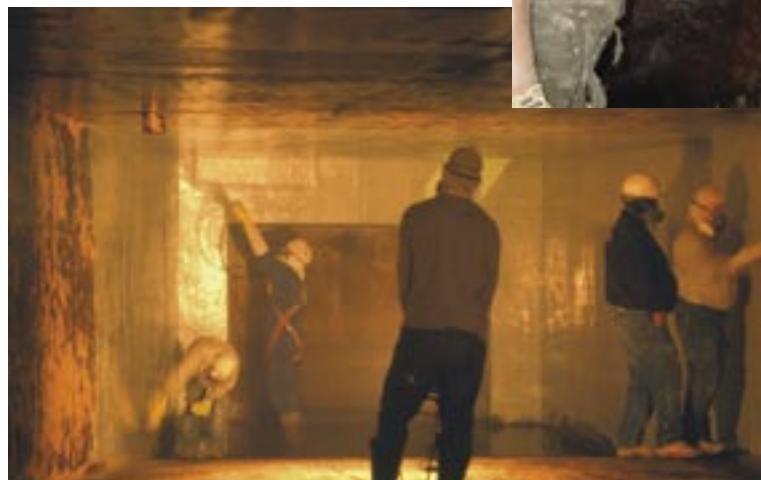
A crew from F&L Concrete Services spray-applies the new coating to protect concrete surfaces from corrosion.

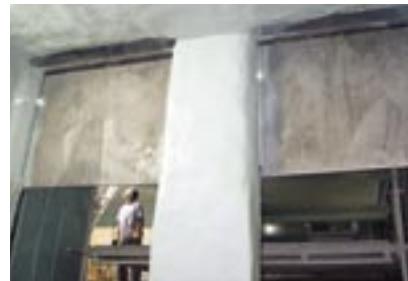
Completed structure after application of 125 mils of Raven 400S 100% solids epoxy coating.
