## Kansas 1993 Steel Tanks

Eight 46' diameter by 21' deep steel scrubber tanks

Structural failure from limestone abrasion and accelerated corrosion

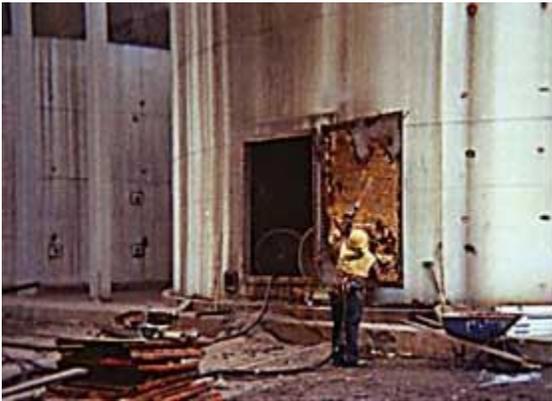
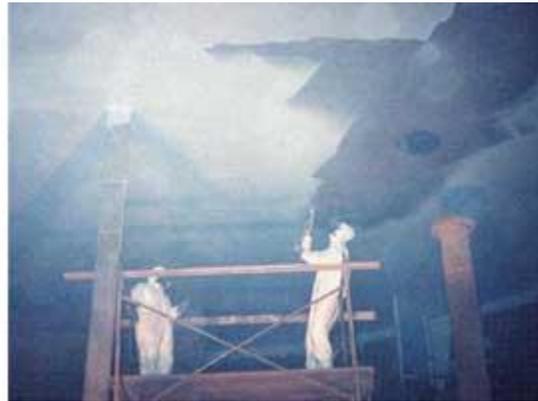
The largest coal fired electric generating facility in the State of Kansas was faced with a decision to rehabilitate or replace its eight 46' diameter by 21' deep scrubber tanks in 1993. The steel tanks contained 10% limestone slurry for cleaning coal exhaust. The tanks were experiencing structural failure due to abrasion from the limestone slurry and accelerated corrosion resulting from 185°F 10% slurry and captured sulphur dioxide. The 3/8" steel walls had numerous leaks from corrosion, the worst of which resulted in large welded patches to compensate for surrounding weak and thin areas. Previous coatings had been moderately successful in preventing corrosion but required multiple coats with narrow windows of time, weather conditions, re-coatability, etc. The only remaining alternative was to line the tanks with stainless steel.

The tanks were rehabilitated using Raven 405, a 100% solids ultra-high build epoxy. Surface preparation consisted of sandblasting the interior surfaces to SSPC-10 specification. An ultrasonic thickness gauge was utilized to scan the sandblasted surfaces for structurally deficient thin spots (less than 50% of the original 3/8" thickness). Areas identified for "patchwork" received a structural epoxy patch consisting of a 60 mil tack coat of Raven 405 inlaid with 18 oz/yd<sup>2</sup> fiberglass woven roving fabric. The structural repair areas and remaining tank surfaces were then lined with a monolithic 75 mil single coat of Raven 405, at a rate of approximately 800 sq. ft. per hour in high humidity conditions. Five tanks (5,000 sf each) were turnkey prepared, structurally patched, lined, spark tested for holidays and pinholes, then touched up in

This project was performed in the summer of 1993. The tanks were inspected one year later and required minimal patching around welds, joints, and areas where mechanical damage had occurred. Patching was simply performed by cleaning and lightly abrading designated areas, then brush applying Raven 405. Raven has outperformed all other coating systems used to date, and the client has specified Raven's coatings for future work.
