## Historical Report Tulsa, OK Manhole

**Location:** Tulsa, Oklahoma (West 42<sup>nd</sup> Place South)

**Owner:** City of Tulsa

**Inspection Date:** August 10<sup>th</sup> 2015

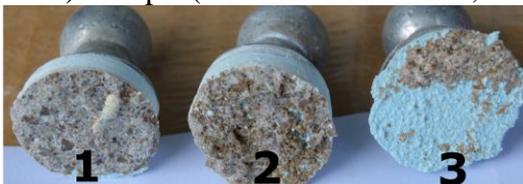
**Structure 1:** This was manhole #247. It was a 5.5' deep manhole with repairs to both the inlet and outlet. There were numerous patches on the coating that appeared to have been small holidays. No active leaks were noticed. This manhole had three 20mm dollies glued and cored to the coating.

- 1) 280psi (100% substrate failure)
- 2) 198psi (95% substrate failure, 5% adhesive failure)
- 3) 195psi (25% substrate failure, 75% adhesive failure)

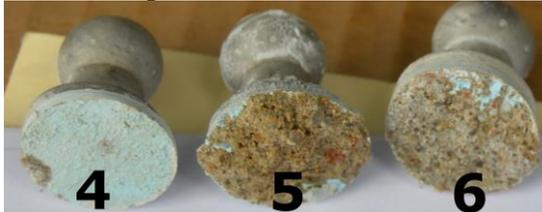
**Structure 2:** This was manhole #248. It was a 7' deep manhole with repairs to both the inlet and outlet. One active leak was noted on the south side approximately 1' above the bench. Unrepaired holidays were noticed, but were not leaking. Three 20mm dollies were glued and cored to the surface of the coating.

- 4) 500psi (5% substrate failure, 95% adhesive failure)
- 5) 420psi (95% substrate failure, 5% adhesive failure)
- 6) 460psi (90% substrate failure, 10 adhesive failure)

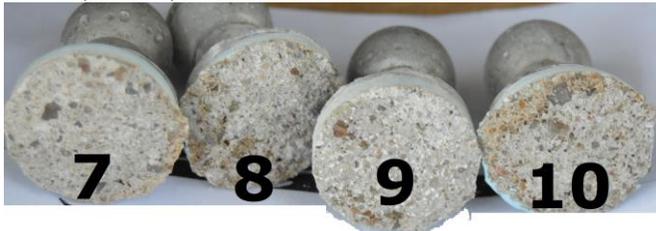
**Structure 3:** This was manhole #249. It was a 7' deep manhole with previous repairs to the outlet pipe. There was cracking of the coating around the transition from the concrete manhole to the cast ring. Four 20mm dollies were glued and cored to the surface of the coating.

- 7) 605 (100% substrate failure)
- 8) 400 (100% substrate failure)
- 9) 380 (100% substrate failure)
- 10) 485 (97% substrate failure, 3% adhesive failure)
