## Junction Box Tulsa, OK

Tulsa, Oklahoma

City of Tulsa

### **Description of Application**

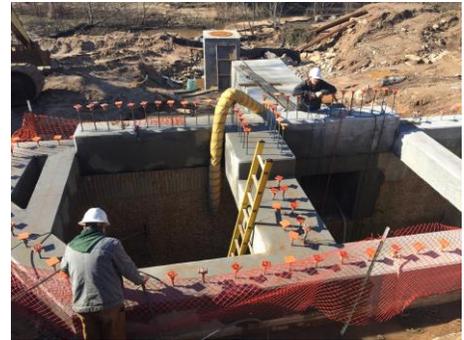
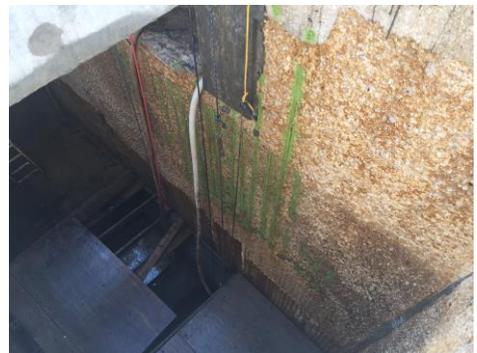
The structure was built in the early 1980s and a PVC liner was used to provide corrosion protection. Upon annual inspections, flaws in the PVC liner were found and spot repairs were attempted at additional costs to the City of Tulsa to prolong the life of the liner. After roughly twenty years of continually maintaining the liner, a more in-depth inspection was conducted. It was found that the liner was no longer providing adequate corrosion protection and the structure was in very poor condition behind the liner due to deterioration from H<sub>2</sub>S and sulfuric acid. It was clear that the liner needed to be removed and the structure rehabilitated.

The structure's overflow channel had deteriorated to the point of collapse. The top and ceiling had to be completely removed and redesigned. Both structures were replaced by forming up new walls and ceilings then poured in place. The walls had lost over three inches of cement, exposing rebar. Once all the contaminated and/or deteriorated portions of the substrate were removed by high pressure water blasting the exposed rebar was sandblasted and coated to protect it from further corrosion. Spots of highly deteriorated substrate on the walls required large cement repairs and then the entire structure had to be resurfaced with a spray applied cement 2" to 3" thick. After all surfaces had been
