Pinholes & Holidays

Technical Bulletin

PINHOLES – Everything You Need to Know AND How to Avoid Them...

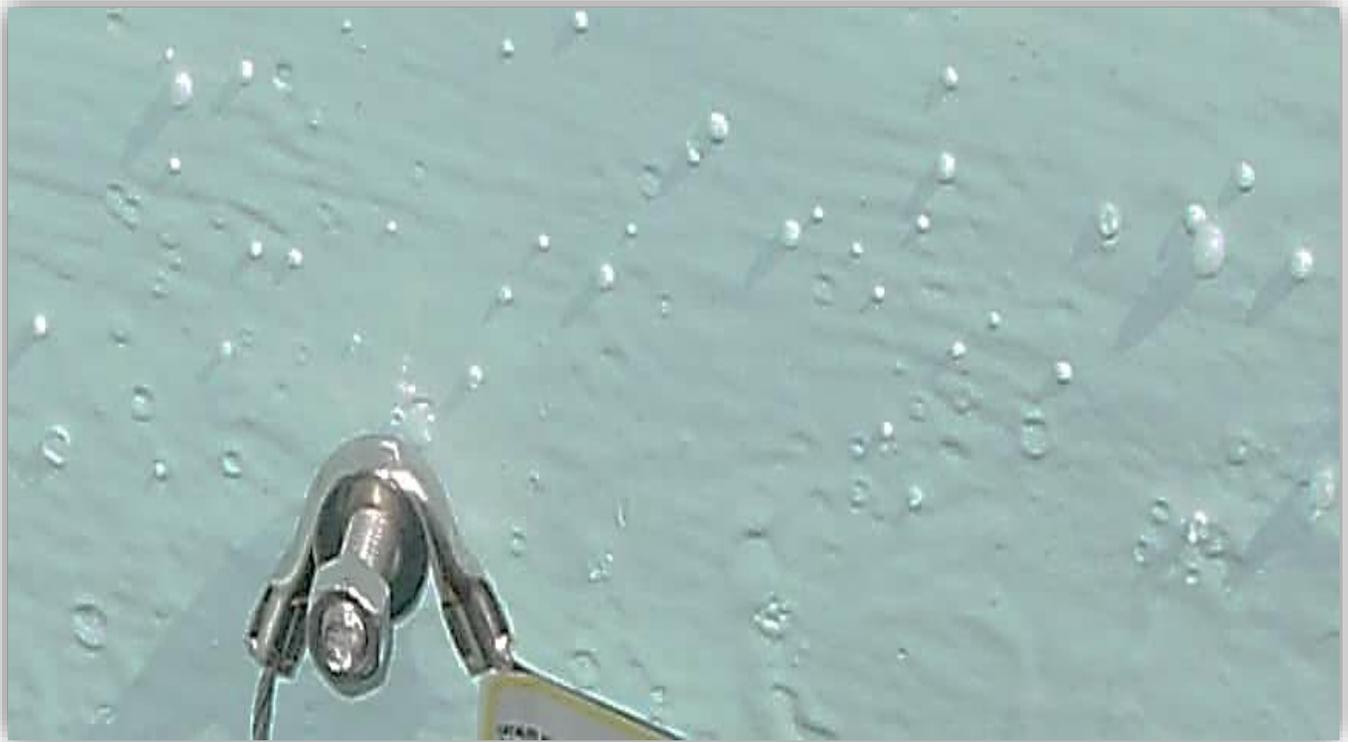
Pinholes in Raven 405 due to off gassing on a concrete tank. Substrate temperature had increased only 3 degrees due to intermittent sun exposure. Adjacent wall was coated without pinholes the previous day, there was no sun exposure that day. This wall was resprayed at night after temp fell 5 degrees and did not pinhole.

- Avoid coating application and cure during rising changes in substrate temperature
- Avoid the introduction of water to concrete
- Allow for equalization of the relative humidity of the concrete to the surrounding atmosphere
- Open up subsurface voids using abrasive blasting or aggressive water cleaning (min. 5000 psi)
- Densify the substrate surface

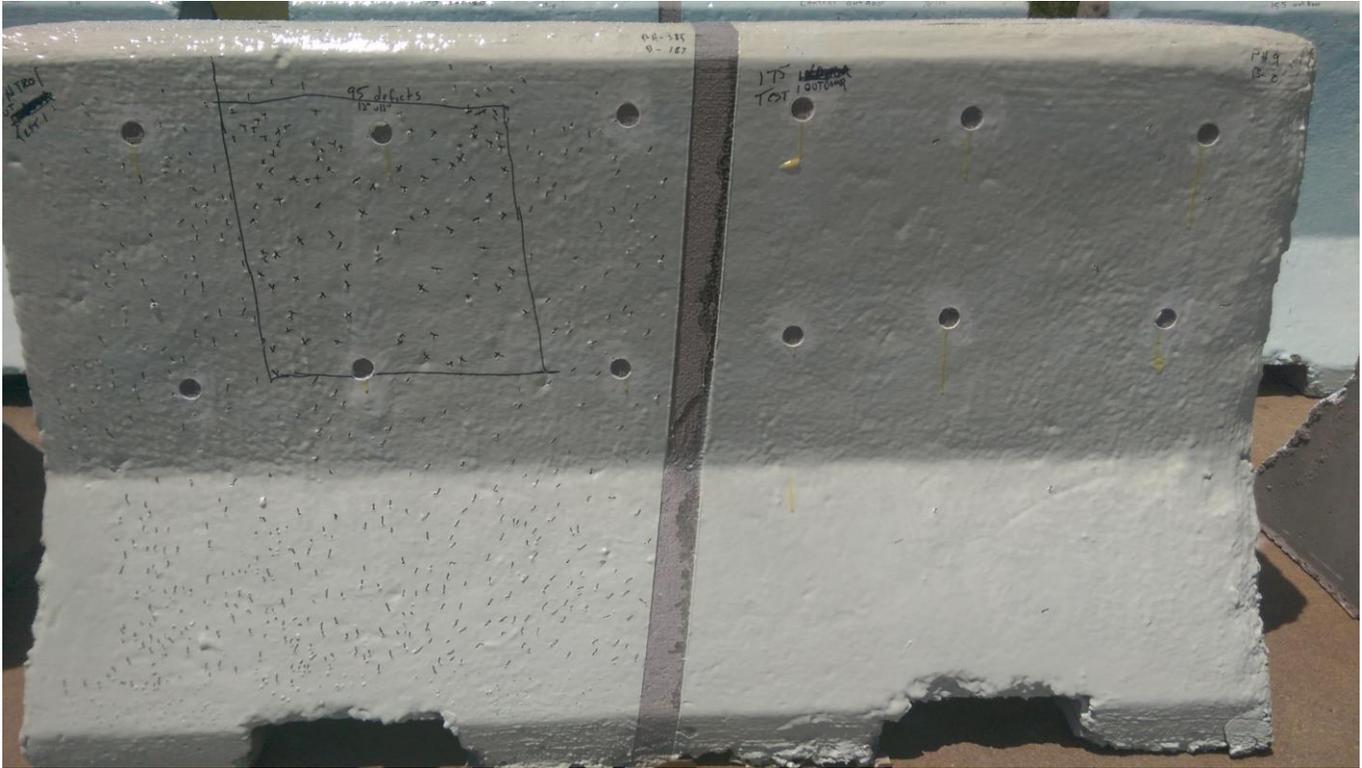
****Both sides were coated at the same time. No primer was used on the left block of the concrete before coating, resulting in numerous pinholes. The right side of the block was primed with Raven 175 before being top coated. As result, pinholes were drastically reduced if appearing at all.***

- Shade, cover or otherwise protect the substrate from sunlight to minimize the resulting rise in substrate temperature
- Apply a penetrating primer such as Raven 155, 171, 171FS, and 175 to seal the surface.
