## Chambers Creek, WA Pierce County WWTP Digester #1

Chambers Creek WWTP Pierce County, WA, 80' Diameter Sewage Digester

### **Rehabilitation Process:**

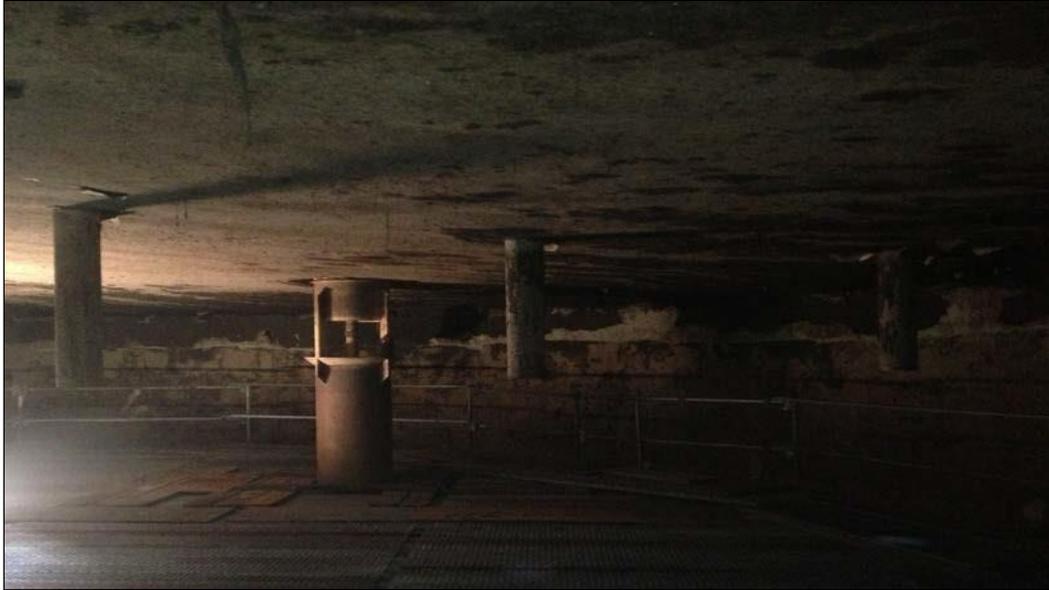
The third coating system lasted longer than the first two coating systems but began failing after almost eight years in service. The third coating failure was most likely a result of the coating being applied to a surface that lacked a sufficient surface profile in order for the coating to bond, and the coating thickness was too thin for service in these environmental conditions.

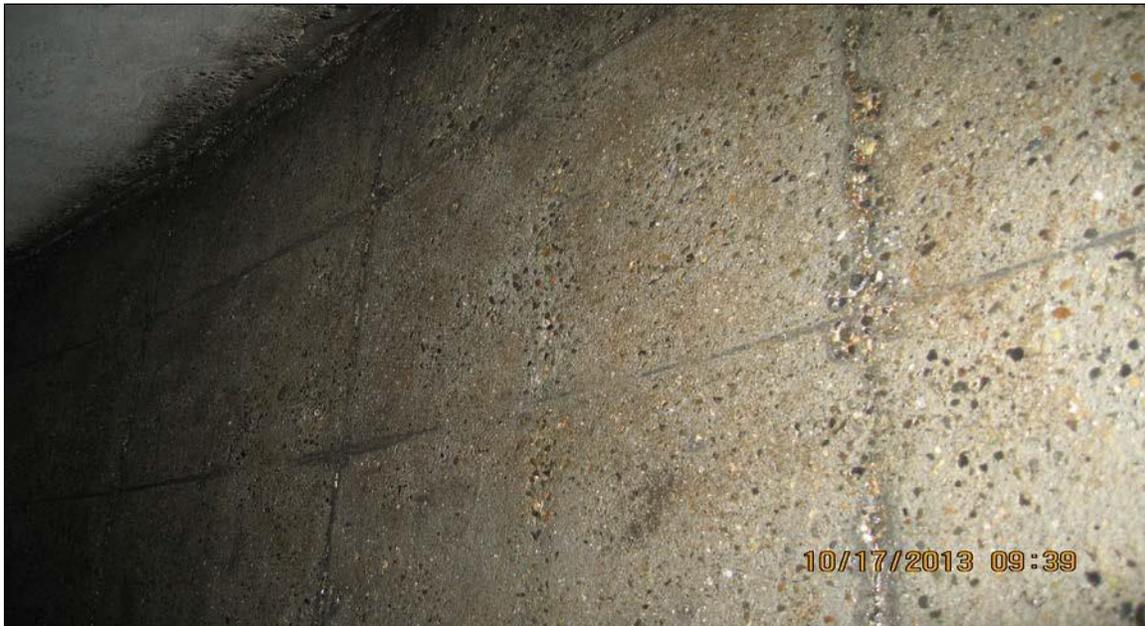
Most of the failing coating on the ceiling was already peeling off along with the majority of the coating on the walls. Once the remaining coating had been removed using power scrapers, chisels, and other tools, the concrete substrate was abrasive blasted in accordance to a minimum of an IRCI Concrete Surface Profile CSP4 and to

provide adequate surface profile for the new coating system to adhere to. In some places where heavy corrosion had occurred, the profile exceeding CSP10. At all points which Raven Lining Systems 405 coating was applied to terminate a minimum of a ¼" wide X ¼" deep termination groove was saw cut into the surface of the structure at a slight angle. The coating system was applied into the groove filling it and slightly overlapping it. After all the blasting and preparation work was completed, the structure was thoroughly cleaned and allowed to dry.

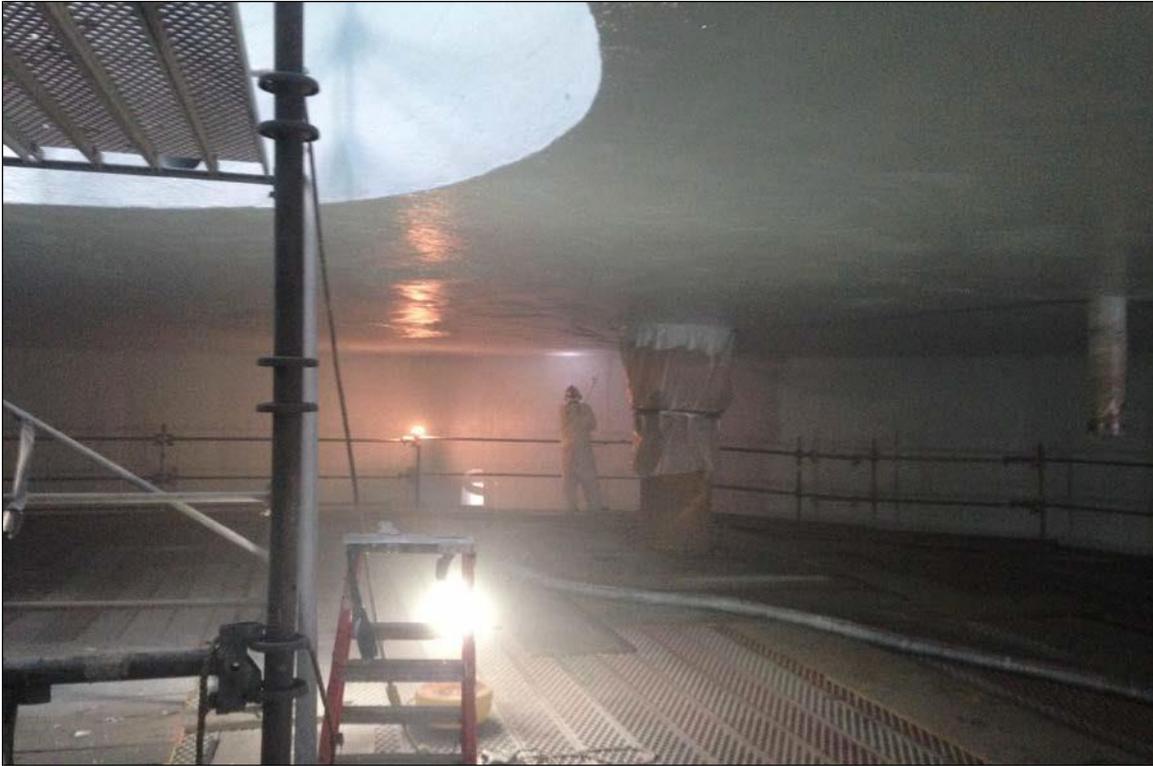
After Raven 155 had cured for a sufficient amount of time and within the recoat window, the application of Raven 405 Trowel to roughly 3625 square feet applied at 95 mils thick on average was conducted. It was back rolled / troweled to fill all the voids, bug holes and level the rough areas. The resurfacing coat of Raven 405 Trowel was allowed to cure sufficiently and then the application of the Raven 405FS began. Over 7995 square feet was coated with the Raven 405FS at an average mil thickness of 135 mils.

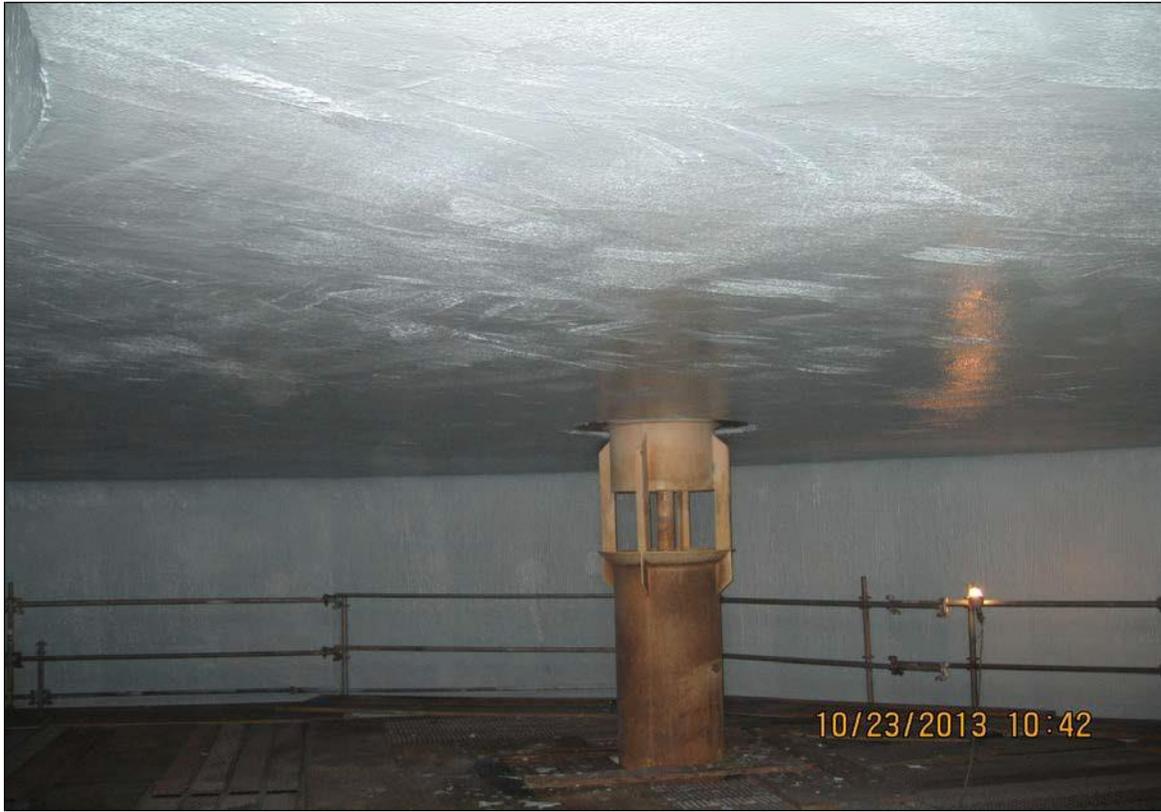
Adhesion testing was also performed in accordance to ASTM D7234 - Pull-Off Adhesion Strength of Coatings on Concrete Using Portable Pull-Off Adhesion Testers. Thirty-nine dollies were placed, and pull testing was conducted. A minimum range of 250-500PSI was required for a successful test. Five of the 39 dollies were

excluded because of a glue failure. All other dollies exceeded the minimum PSI range, in which the tests were stopped to prevent damage to the coating system.
