Tanks Telluride, CO

At roughly 9250 feet above sea level, two 260,000-gallon potable water tanks lay in the picturesque town of Telluride. The tanks were built between 1920 and 1930; and it was thought that the tanks were made of concrete, but after the west tank rehabilitation project began, it was found that at least the upper 4 feet of the tank was constructed with stacked stone. At some point in the west tank's life it had been coated with gunite products to the average thickness of 3 inches. This was most likely done to provide structural stability and water tightness. Unfortunately, the west tank continued to leak excessively, and in the 1970's a Hypalon liner was installed. The Hypalon liner worked well for forty years with only small repairs needed, but the cost of such repairs grew to the point that it was no longer cost effective to maintain the liner. Also, it was found that greater than 2.1 million gallons of water were still lost annually. A tank replacement cost estimate was completed and determined that it would be more than 4 million dollars to build new tanks at the same location. This was not only due to the cost of the tanks, but also because the road leading up

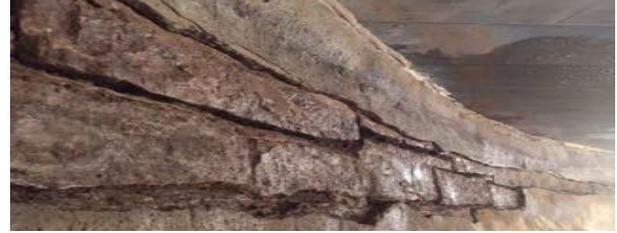
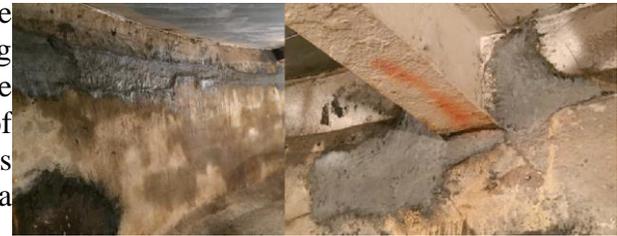
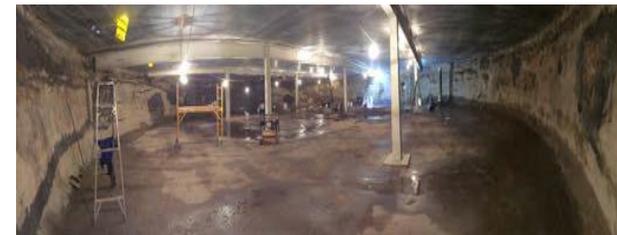
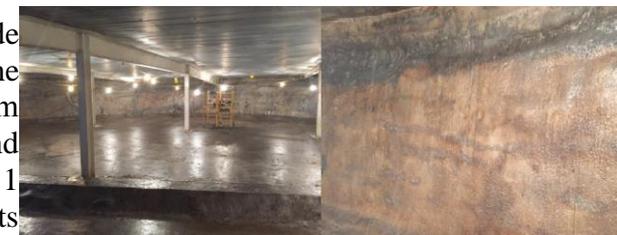
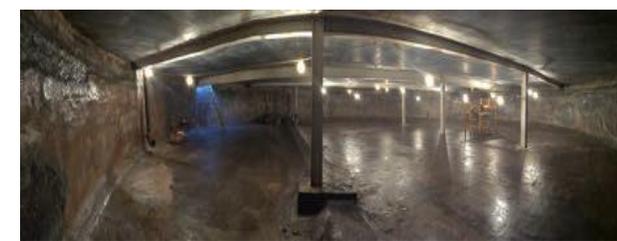
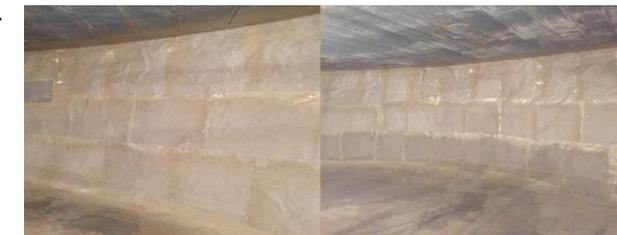
In October 2016, a contract was issued to John LaDuke and Global Linings of Gunnison, CO to rehabilitate the western tank using products manufactured by Raven Lining Systems. Once the old liner had been removed, large portions of the gunite fell off the walls and hollow stops were found. All the loose gunite was removed, exposing the stacked stone beneath, and most of the mortar between the stones was lost. A thorough cleaning was completed with water and then cement repairs of the structure commenced. Large holes at the end of the roof support beams had to be filled along with two old pipe inlets and outlets along with all other surface defects using a polymer modified cement (Raven 760 HPPC).

Once all the damaged areas had been repaired, the tank was cleaned for the application of Raven 155 water-borne penetrating primer in two coats to seal and strengthen the repairs and the structure's surface. After the Raven 155 cured, a coat of Raven 175 100% solids epoxy primer was applied within the recoat window. This was completed to further seal the structure and provide enhanced adhesion of the Raven 511 to the substrate. The Raven 511 and Raven 506's rapid cure rate required them to be spray applied using plural component equipment and air purge impingement spray guns. The coat of Raven 511 on the walls provide an adhered water tight liner and acts as an adhesive for geotextile fabric that was inlayed into the 511 while it was still in the wet/tacky state within the curing process.

The outside of the tank roof was cleaned and prepared then coated with Raven 511 to seal it from leaking dirty water and debris into the tank, as well as acting as a barrier coating for corrosion prevention. With the walls lined with 511 and fabric inlayed, the entire interior of the tank was coated with greater than 125mil of Raven's NSF61 potable water approved AquataFlex 506. The 506 applications are a semi-adhered watertight flexible liner. The 506 was also applied over the roof's support beams and legs to provide a further barrier coat and protection
