## Historical Report Tulsa, OK Manhole

**Location:** Tulsa, Oklahoma (West 42<sup>nd</sup> Place South)

**Owner:** City of Tulsa

**Inspection Date:** August 10<sup>th</sup> 2015

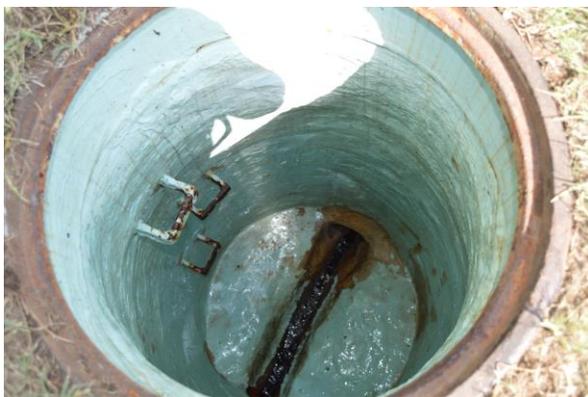
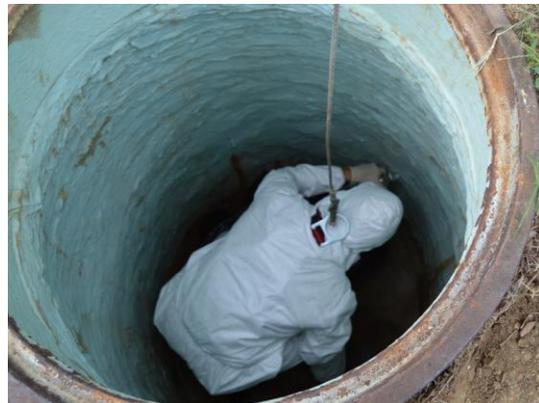
**Structure 3:** This was manhole #249. It was a 7' deep manhole with previous repairs to the outlet pipe. There was cracking of the coating around the transition from the concrete manhole to the cast ring. Four 20mm dollies were glued and cored to the surface of the coating.

- 7) 605 (100% substrate failure)
- 8) 400 (100% substrate failure)
- 9) 380 (100% substrate failure)
- 10) 485 (97% substrate failure, 3% adhesive failure)
