Adhesion Testing Pocket Guide

QA for proper:

- Substrate quality
- Surface preparation
- Coating application

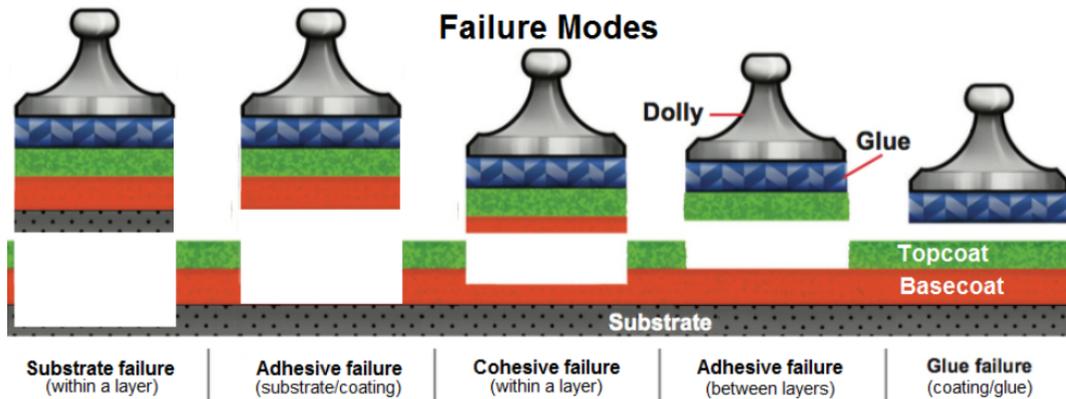
- **Substrate failure:** Failure occurs within the substrate layer (substrate is on the dolly and the structure).
- **Cohesive failure:** Failure occurs within the coating layer (same coating on the dolly face and the coated surface).
- **Adhesive failure:** Failure occurs at the interface between two layers (coating on the dolly face differs from the surface).
- **Glue failure:** Failure occurs in the separation of the glue from itself, the coating, or the dolly (no coating visible on the dolly face).

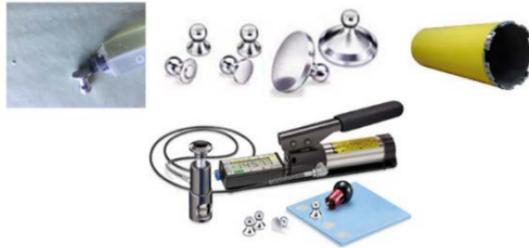
Equipment Requirements

Testing apparatus, Epoxy adhesive, mixing stick, fine grit sandpaper, clean rags, solvent, duct tape, Permanent marker, scoring device (if required)

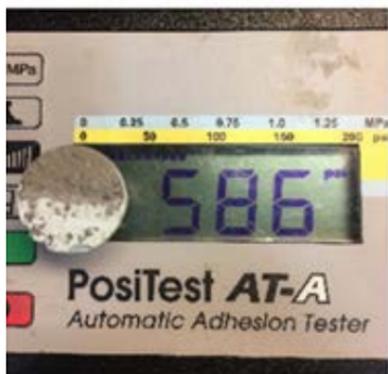
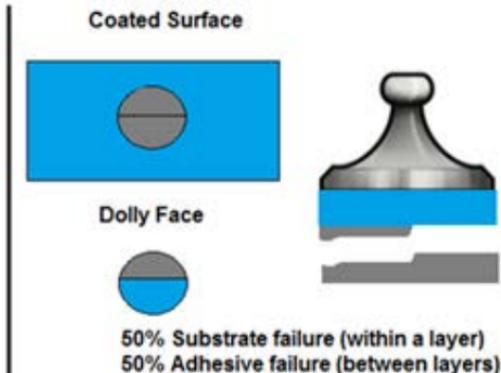
Location: North Wall of MH at 4' up from bench

Acceptable test results: Yes

Pull-Off Strength: 586 psi

Failure Mode: 50% Cohesive failure within the substrate /
50% Adhesive failure between the coating and the substrate

Observed Coating Thickness: N/A

Evaluation: The coating exhibited expected strength when subjected to the test and did not separate 100% within the substrate. With the strength of the pull, this test is acceptable according to the specification. (Greater than 500 psi)

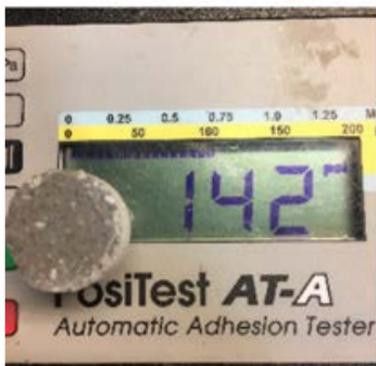
100% Substrate failure (within a layer)

Location: Bench, west side of the invert (dolly #2)

Acceptable test results: questionable

Pull-Off Strength: 142 psi

Failure Mode: 100% Cohesive failure within the substrate

Observed Coating Thickness: Yes, 128 mils

Evaluation: The coating adhered to the substrate with 100% cohesive failure within the substrate.

Coating adhered to a weak substrate, with 100% cohesive failure. Owner should evaluate original substrate due to weak substrate strength.

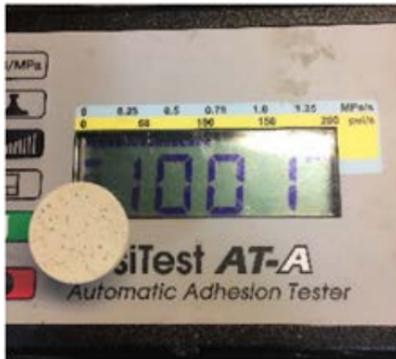
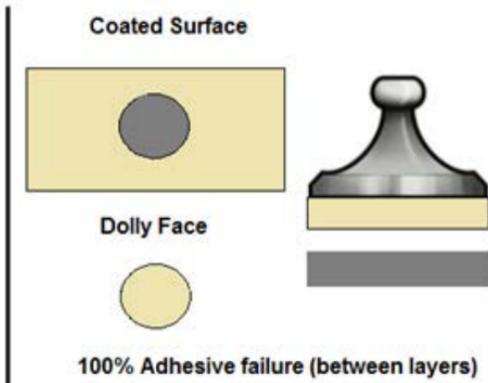
Location: Clarifier floor, east side by manway entry

Acceptable test results: Yes

Pull-Off Strength: 1001 psi

Failure Mode: 100% Adhesive failure

Observed Coating Thickness: Yes, 210 mils

Evaluation: Coating failure was NOT within the substrate. Due to the high PSI strength (over 500) of the pull. This test is acceptable.

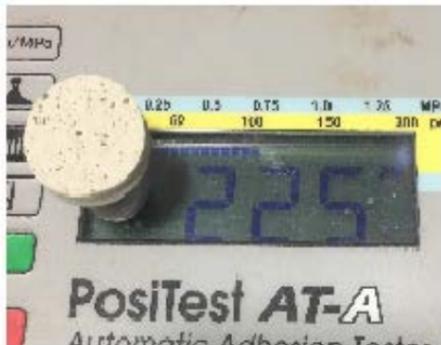
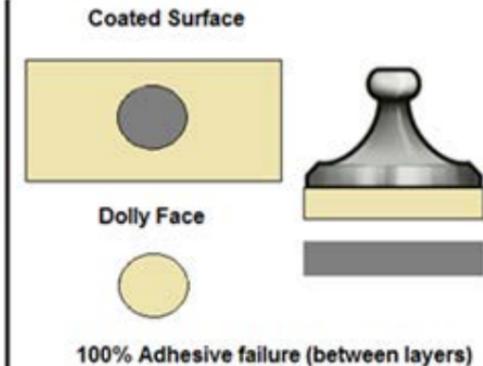
Location: Upper left corner of wet well #8

Acceptable test results: No

Pull-Off Strength: 225 psi

Failure Mode: 100% Adhesive failure

Observed Coating Thickness: N/A

Evaluation: Coating failure was NOT within the substrate. Due to the low PSI strength and lack of substrate on the dolly, this test is NOT acceptable.

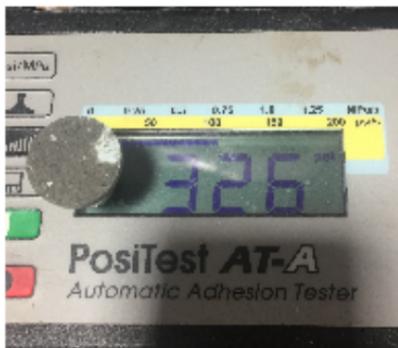
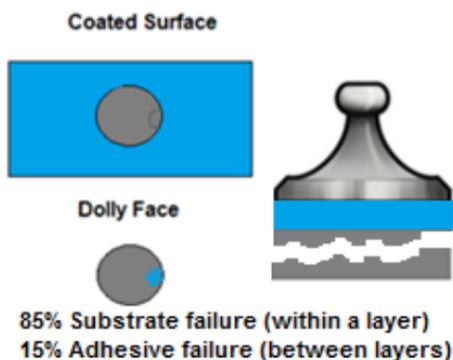
Location: Tank #213 floor, below ladder

Failure Mode: 85% cohesive failure within substrate / 15% adhesive failure

Observed Coating Thickness: 125 mils

Evaluation: Failure was 85% within the substrate. With the combined substrate percentage and PSI strength on the dolly, this is an acceptable pull.
