City of Charleston and Raven A6: 15 Years Later and Still Standing the Test of Time

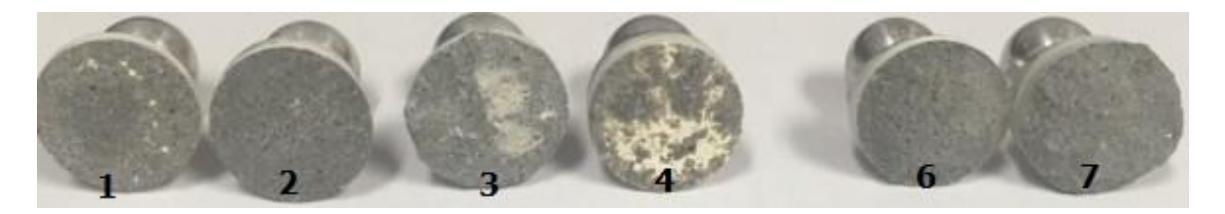
Adhesion testing was performed on the 15 year old AquataPoxy by gluing seven 20mm dollies to the coating surface with a fast setting, high strength epoxy. After allowing the glue to set for 24 hours the dollies were then cored using a 20mm coring hole bit. The adhesion test was perform using a Defelsko Positest AT. All tests were perform in Filter Basin #10

- Pull 1: 619psi (95% substrate, 5% cohesive failure in coating)
- Pull 2: 714psi (100% substrate failure)
- Pull 3: 488psi (100% substrate failure)
- Pull 4: 621psi (40% substrate, 60% adhesive failure between substrate and coating)
- *Pull 5: 251psi (75% substrate, 25% adhesive failure between substrate and coating)*
- Pull 6: 723psi (100% substrate failure)
- Pull 7: 511psi (100% substrate failure)
