Historical Report Cedar Park, TX Manhole

Location: Cedar Park, Texas (1220 N Bell Blvd.)

Inspection Date: September 17th 2015

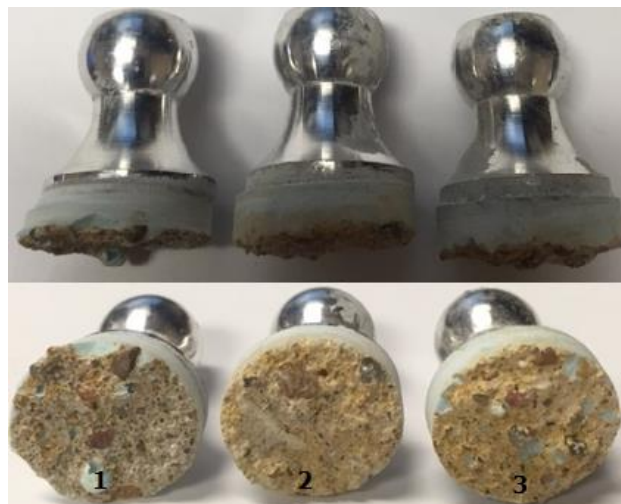
Structure 1: This manhole was located at 1220 N. Bell Blvd. Cedar Park, TX next the train tracks. This manhole had three 20mm dollies glued to the coating and cored.

The resulting pulls were:

- 1) 575psi (95% substrate failure, 5% adhesive failure)
- 2) 317psi (100% substrate failure)
- 3) 403psi (90% substrate failure, 10% adhesive failure)
