## Historical Report Cedar Park, TX Manhole

**Location:** Cedar Park, Texas (245 Quicksilver Dr.)

**Inspection Date:** September 17<sup>th</sup> 2015

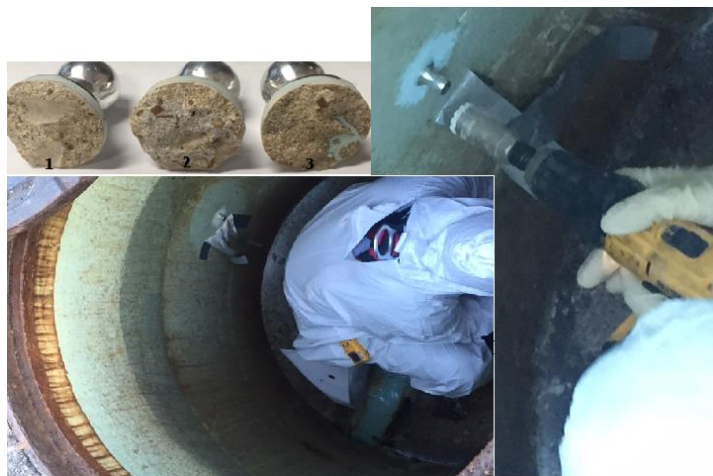
The manhole was coated in 2004 with Raven 405 with an average of 125 mils. There were no visual defects or active leaks in the coating.

**Structure Results:** This manhole was located at 245 Quicksilver Dr. Cedar Park, TX, centered in the road. This manhole had three 20mm dollies glued to the coating and cored.

- 1) 573psi (100% substrate failure)
- 2) 500psi (100% substrate failure)
- 3) 665psi (90% substrate failure, 10% cohesive failure)
