Charleston, SC 1998 Brick Manhole

11th and Grove Street, Charleston, South Carolina

August 1998

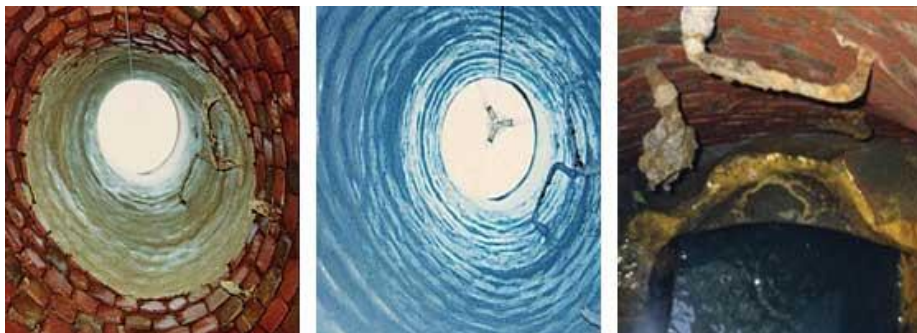
Pipe joint leaking and bench severely eroded with voids

Rehabilitate and coat to low flow but unable to divert or plug lines. Hydraulic cement was used to fill large voids where mortar missing 1/2" and greater. The bench was rebuilt, voids filled and chemical grouts were injected up to 2' into the annular spaces surrounding the CIPP line where infiltration was visible. Raven 405 was applied at minimum of 125 mils providing structural enhancement and corrosion protection.
