## **City of Charleston and Raven A6: 15 Years Later and Still Standing the Test of Time**

### **Upgrade: AquataPoxy Application Process**

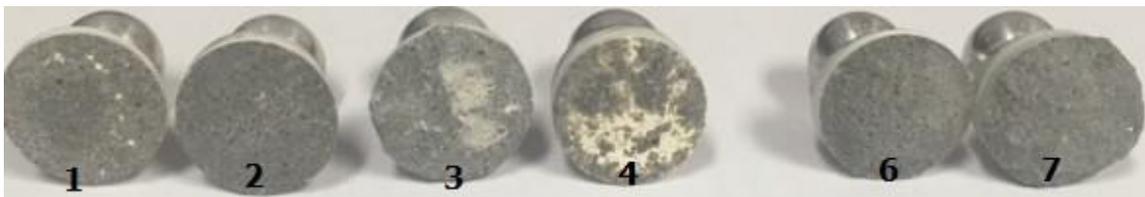
Adhesion testing was performed on the 15 year old AquataPoxy by gluing seven 20mm dollies to the coating surface with a fast setting, high strength epoxy. After allowing the glue to set for 24 hours, the dollies were then cored using a 20mm coring hole bit. The adhesion test was performed using a Defelsko Positest AT. All tests were performed in Filter Basin #10

*Pull 1: 619psi (95% substrate, 5% cohesive failure in coating)*

*Pull 2: 714psi (100% substrate failure)*

*Pull 3: 488psi (100% substrate failure)*

*Pull 4: 621psi (40% substrate, 60% adhesive failure between substrate and coating)*

*Pull 5: 251psi (75% substrate, 25% adhesive failure between substrate and coating)*

*Pull 6: 723psi (100% substrate failure)*

*Pull 7: 511psi (100% substrate failure)*
