## Henderson, NV 1998 Manhole

Railroad Pass Lateral, Henderson, Nevada

[Raven 405](#)

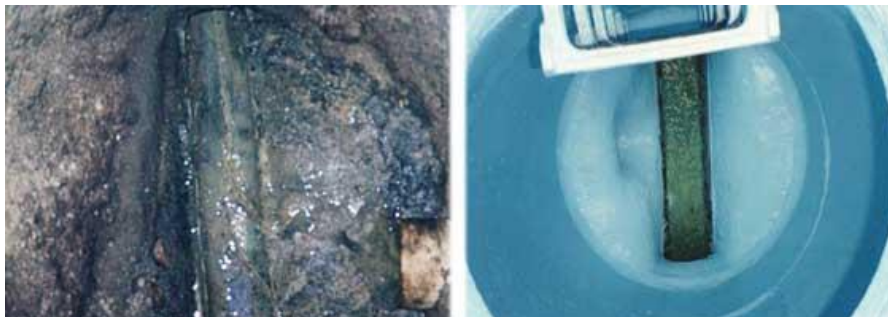
The bench was completely deteriorated and the corrosion was very severe

The project began by water-cleaning at 5,000 psi. 5 gpm was used to prepare a clean, sound substrate to receive the coating. 3" of severely corroded concrete was removed. Then, a light patching of walls was performed, along with a complete rebuild of the bench, with contour to create flow into invert. Next, the grade ring was sealed. Raven 405 was applied at 200 mils, providing structural enhancement and corrosion protection.
