Houston, TX 1999 Steel Potable Water Tank

Bolted, galvanized steel, 250,000 gallon potable water tank.

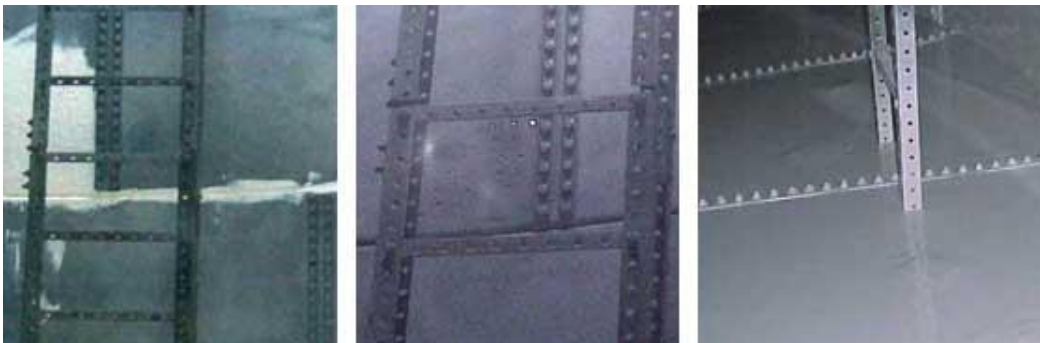
Condition before restoration included 72 holes in the shell, seam leaks and 124 holes in floor

Surface preparation of near white blast was performed. Following surface prep, large holes were patched and fiberglass mesh inlaid. Walls were coated with three coats of AquataPoxy® A6 at 5-8 mils; total DFT of 16-24 mils; floor total DFT of 40 mils. An inspection in 1999 revealed the tank to be in "as good as new" condition.
