New York, NY 1994 Tunnel Breezeway

[Raven 405](#)

Tunnel Breezeway

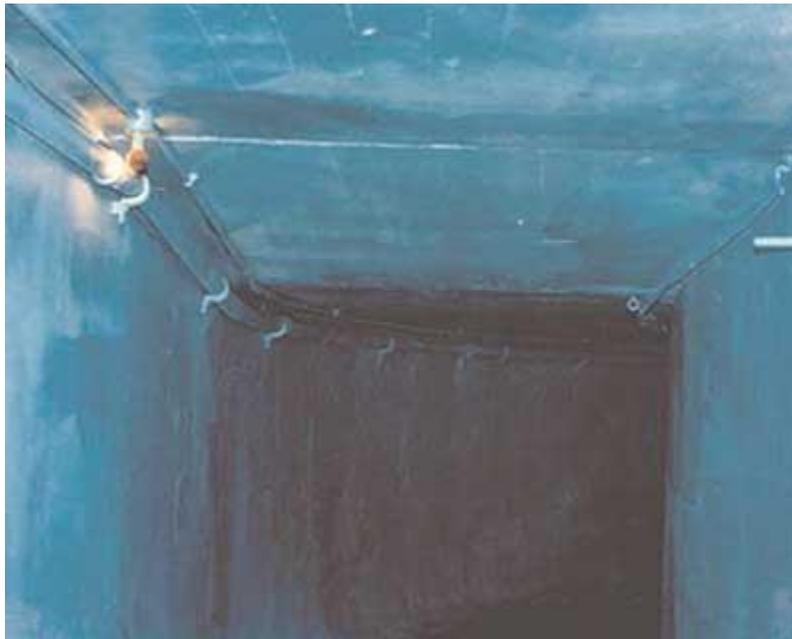
There was corrosion due to saltwater infiltration.

At high tide, cracks in the steel-reinforced concrete absorbed the seawater and exposed the concrete and steel to chloride and sulfate ions, and oxygen from inside the tunnel. As the concrete dried, the salts would crystallize which helped induced spalling of the concrete. Corrosion cells also developed allowing the formation of rust scale at the reinforcing steel. Continued cycling caused severe disintegration to occur on the inside wall of the tunnel, particularly along construction joints where infiltration was active. In these areas, rusting steel expanded and ruptured the concrete surface.

These actions, coupled with freeze-thaw conditions, caused the severe deterioration of the tunnel's interior walls. ConEd considered numerous rehabilitation methods; however, the only method which could provide a 100% solution was a composite system utilizing a high strength mortar, and hydraulic cements to fill large voids, stop leaks and restore sound surfaces which would be top coated with 125 mils of Raven 405 Ultra High Build Epoxy.

PIM Corporation, a Raven Certified Applicator, began the rehabilitation by removing spalled and loose concrete and rusted steel. Sound surfaces were then water blasted and active leaks stopped before applying one to 3" of high strength, fiber-reinforced, cement based mortar.

Approximately eight hours later, Raven 405 ultra-high build epoxy was spray applied at an average thickness of 125 mils (1/8").

In addition to Raven's light blue color providing illumination and ease in inspection, the final system supplied enhanced structural strength and superior infiltration and corrosion prevention.
